Cost-benefit analysis case study visit: Turku

Time: 26 November 2013

Place: Turku, Finland

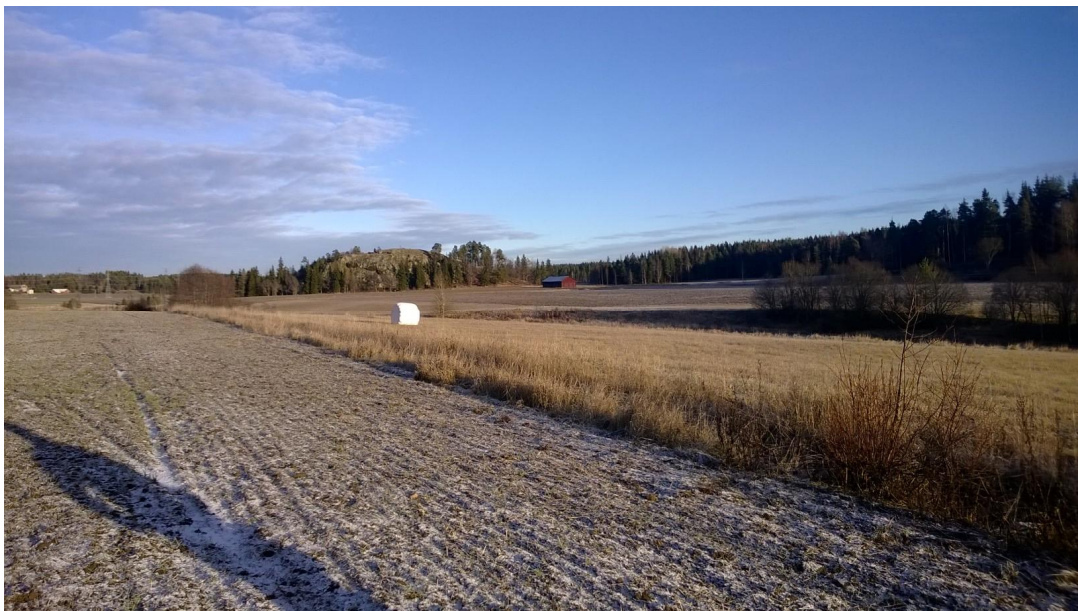
After the lunch the visit continued with tour in the fields. At first we went to see the case field by the river Aurajoki (Picture 2). The buffer zone was 50-85 metre wide, covering the entire slope part of the field by the river side and about fourth of the total field area. A part of the buffer zone area functioned a few decades ago as a research area where runoff experiments were performed. There were couple of silage bales in the field, made by a local cattle farmer. The farmer who rents the field allows the cattle farmer to utilize the hay grown in the buffer zone for free of charge, which at the same time reduces the required management work for farmer.

Picture 2. The case field by the river Aurajoki has 50-85 metres wide buffer zone

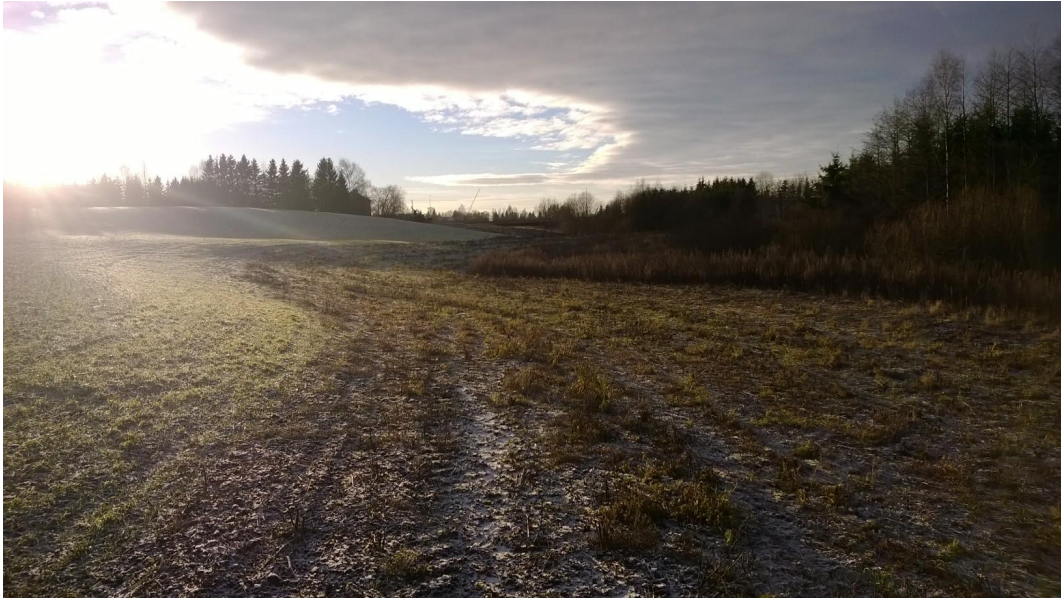
Then we went to see the buffer zone on the case field by the river Vähäjoki (Picture 3), a smaller water course flowing to the river Aurajoki. The buffer zone was established in the spring, so it was

rather new. It was not yet completely vegetated, because the seeds were not properly germinated due to the drought. The establishment will be repeated in the next spring. The width of the buffer zone covered about a third of the width of the slope, and the area of the buffer zone covered about the fifth of the total field area. The grade of the slope was much higher than in the other case field.

Picture 3. The case field by the river Vähäjoki has recently established approximately 20 metre wide buffer zone
